4000 TON CHILLER TUBE SHEET PROTECTED WITH BELZONA

ID: 1032

Application: HEX-Heat Exchangers

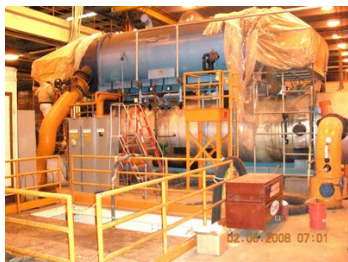
Eroded 72" dia tube sheet faces with leaks between the tubes & the tube sheet

* Chiller with ends shrouded for blast cleaning , * Division plate & end cover , * Corked & coated , * Corks removed ,

Application was carried out in accordance with Belzona Know-How System Leaflet HEX-1. A total of 52 units of 3kg plus 70 units of 1kg of Belzona® 1121 and Belzona® 1321 were used.
