# Belzona 1111 fixing a scored shaft

ID: 10367

Industry: Pulp & Paper  
Application: MPT-Mechanical Power Transmission

Substrate: Carbon steel  
Products: Belzona 1111 (Super Metal), Belzona 9411 (Release Agent)

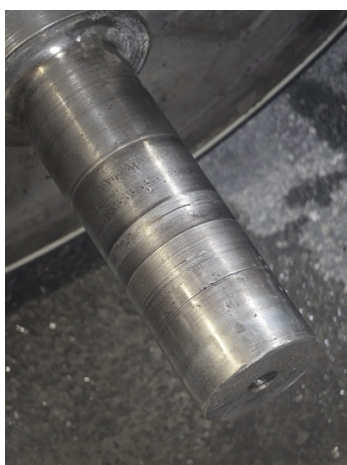
Minor scoring on the shaft in the bearing area. The roller had been rebuilt, and the customer wanted to repair the shaft before reinstalling without causing any further delays. Damaged shafts are a common problem, so this application also served as a training for the in-house maintenance team. The former that was used was made in-house and can be used on other shafts as well.

Original condition of the shaft.

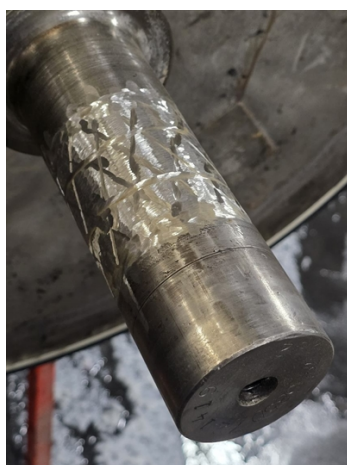
Shaft are prepped using a hand grinder.

A hand grinder was used to prep and roughen the surface, solvent was used to wash the contaminants away, and a heat gun was used for roughly 20 minutes to ensure the material was set in order to remove the former. Emery cloth was used to machine the application to the desired profile.

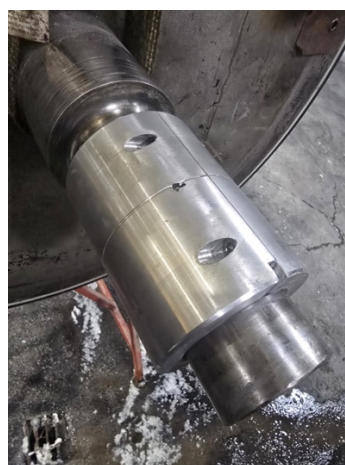
Customer made former in place with the Belzona 1111.

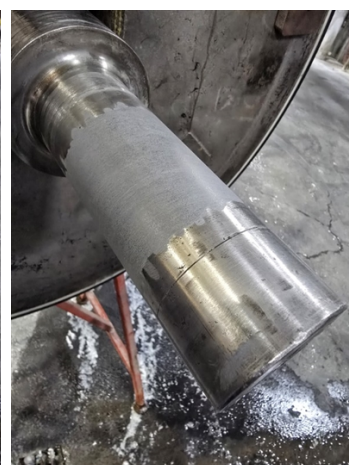
Former removed and the Belzona 1111 refined to the proper profile.
