BELZONA WATERPROOFING ON ALABAMAS TALLEST BUILDING

ID: 1044

Customer Location: *RSA Battle House Tower, Mobile, Alabama*

Application: *RPA-Roof Problem Areas*

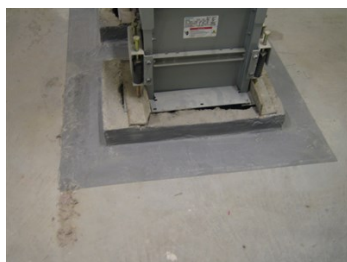
The openings on each floor that allow the power lines to travel the length of the structure were subject to water penetration between the concrete floor and curb

* View of the Tower , * Close up of the Belzona® 3121 , * View of the curbing , * An overview of the power lines ,

The application was carried out in accordance with Belzona Know-How System Leaflet RPA-8

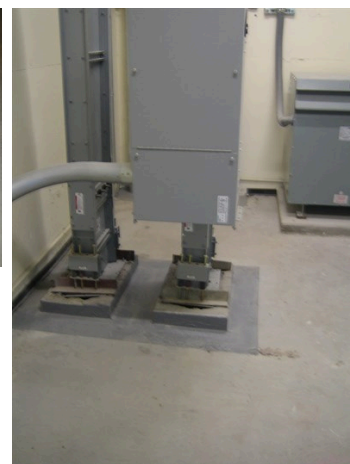
Floor penetrations for the main power lines from the ground floor to the top of the building
