# BELZONA PREVENTS SLIPPING IN WASH AREA

ID: 1053

Industry: General Industry  
Application: FPA-Floor Problem Areas  
Substrate: Concrete  
Products: Belzona® 4151 (Magma Resins)

Customer Location: Dairy, Oklahoma USA  
Application Date: June, 2006

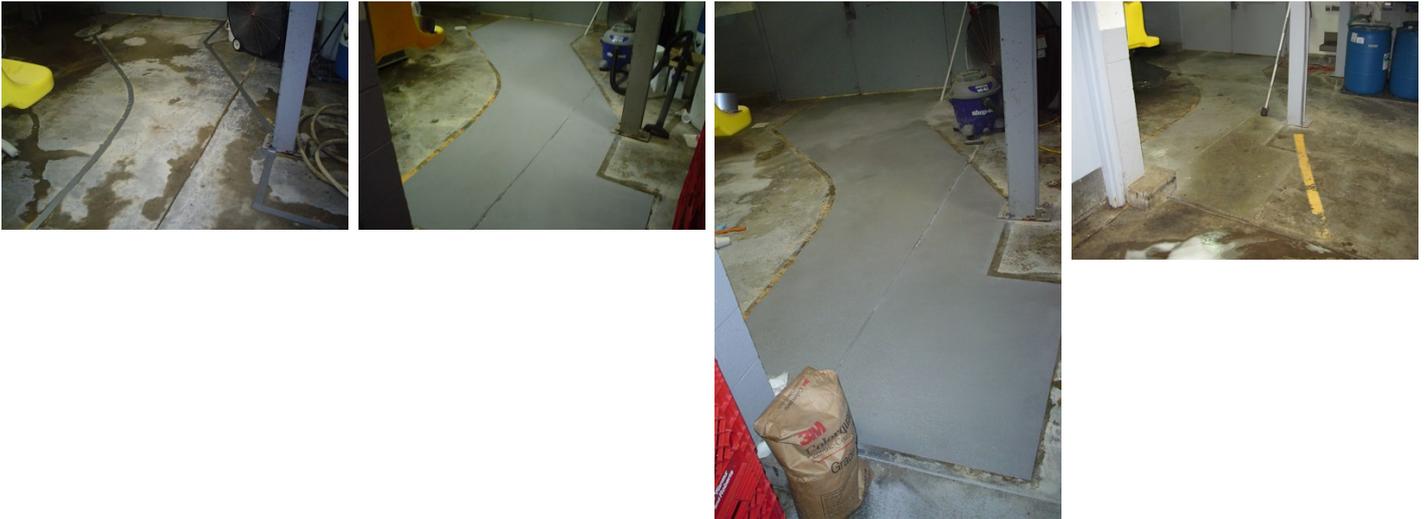
Previous applications of non-slip surfacing had peeled so necessitating a more permanent solution.

\* Surface being cleaned , \* First coat , \* Second coat , \* Almost two years later the floor although dirty is 100% intact ,

Application was carried out using a modified version of Belzona Know-How System FPA-3. after thorough cleaning and abrading, two coats of Belzona® 4151 with a colored aggregate were then applied.
