# BELZONA PROTECTS TUBE SHEET AND TUBES

ID: 1056

**Industry:** Heating, Ventilation & Air Conditioning  
**Application:** HEX-Heat Exchangers  
**Substrate:** Carbon steel  
**Products:** Belzona® 1311 (Ceramic R metal),  
Belzona® 1321 (Ceramic S metal),  
Belzona® 1341 (Supermetalglide),  
Belzona® 5811 (Immersion Grade,

**Customer Location:** Steel mill, Slovakia  
**Application Date:** 2003

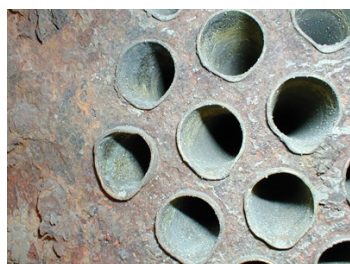
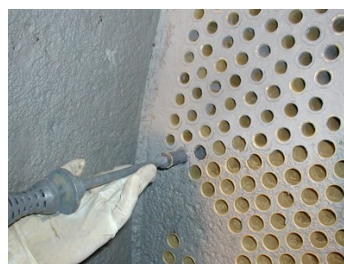
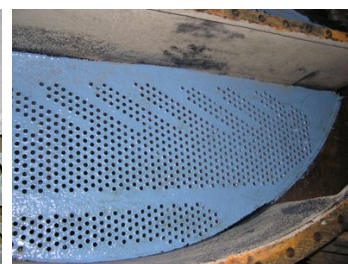
Corrosion problems were beginning on the tube sheet and inlet tubes (50 mm).

Condenser tube sheets and tubes

The application was carried out in accordance with Belzona Know-How System Leaflet HEX-1, HEX-2, and HEX-3.

Belzona provided long term protection, increasing the life of the tube sheet and also inlet tubes, decreasing other repair and maintenance costs. Inspection after three years showed excellent protection being maintained.
