BELZONA IMPROVES CONVEYER EFFICIENCY

ID: 1067

Application: SHM-Solids Handling Machinery

Customer Location: Automotive company, Slovakia

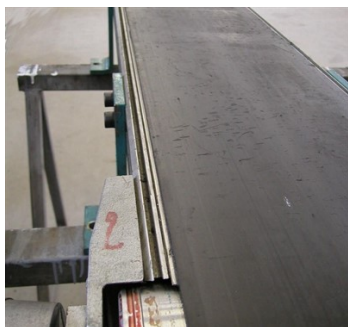
Products were sliding on the belt due to incline and smooth surface.

* Slippery belt , * Application of Belzona® 2211 , * Steel plates for moulding Elastomer to shape , * Completed belt ready to work ,
