BELZONA ELASTOMERS SEAL SF6 GAS LEAKS AT HYDROELECTRIC FACILITY

ID: 1078

Customer Location: Hydroelectric Facility, BC

Leaking joints Gas Insulated Switchgear (GIS)

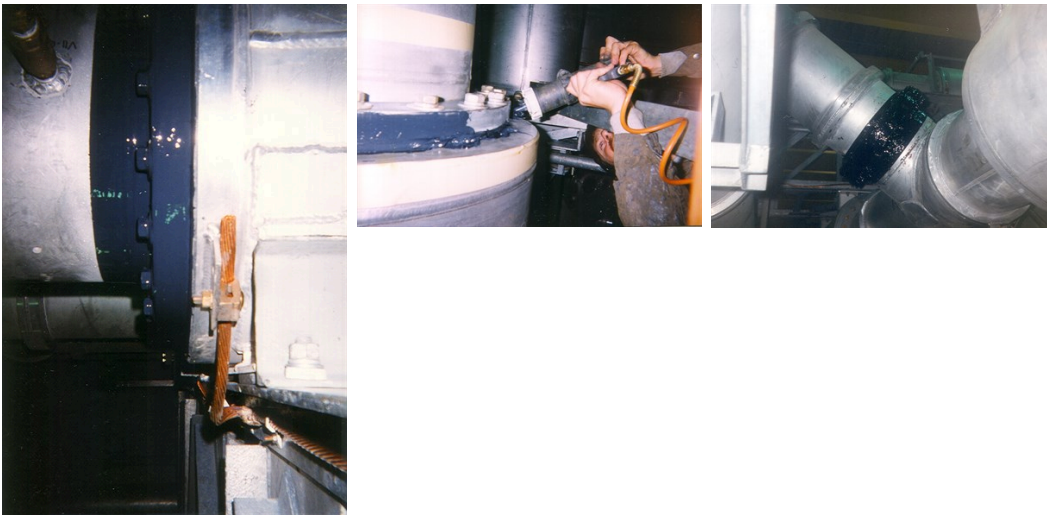
Photograph Descriptions

The constant leakage of Sulphur Hexafluoride gas (SF6) was considered to be a major environmental problem being 25,000 times as effective a "greenhouse gas" as CO2. System is pressurized to 45 psi.

- * Belzona® 2211 MP Hi-Build in the process of being injected into the gap between the two flanges ,
- * Another variation of a similar application ,
- * Another flange sealed ,

Application was carried out in accordance with Belzona Know-How System Leaflet GSS-4. Pinholes in welds were coated with

Belzona® 1321. Flanged joints were sealed with Elastomer using a combination of brush application and injection.

The Belzona materials applied in 1993 have proven completely effective with joints and welds sealed with Belzona materials remaining sealed for well over a decade now. SF6 consumption has dropped from over 50 bottles per year, to a mere two or three bottles—a saving in excess of \$1 million over the decade. Most importantly losses of SF6 into the atmosphere have been minimized, drastically reducing the environmental impact.
