# BELZONA PROTECTS FILTER FROM SHELLS

ID: 1084

Customer Location: Nuclear Power Plant, France

Sea water filter for cooling water circuit of power plant.

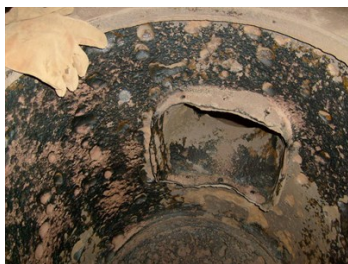
Extensive corrosion and deep erosion of metal

\* State of the filter before repairs , \* Filter after surface preparation and decontamination , \* Filter protected with Belzona® 1321 ,
