# POWER COMPANY APPROVES THE BELZONA SOLUTION

Industry: Power  
Application: CEP-Centrifugal Pumps  
Substrate: Bronze  
Products: \* Belzona® 1321 (Ceramic S Metal) ,  
\* Belzona® 1341 (Supermetalgilde) ,

Customer Location: Nuclear Power Plant, France  
Application Date: January 2007

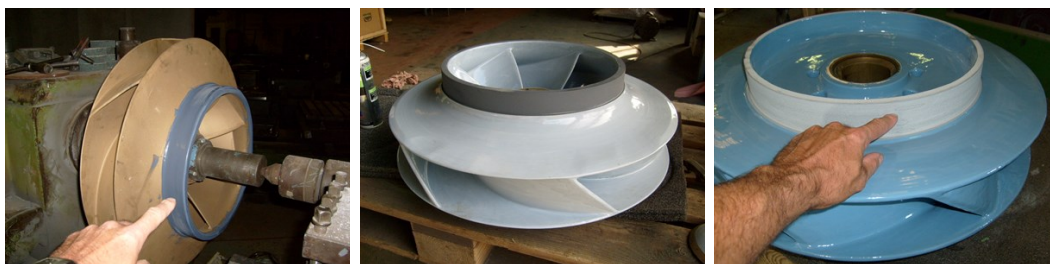
## Photograph Descriptions

Erosion-Corrosion caused by sea water.

- \* Commencement of application with Belzona® 1321 applied to wear ring ,
- \* Application of the first coat of Belzona® 1341 ,
- \* Completed application with wear ring machined to size ,

Application carried out in accordance with Belzona System Leaflet CEP-3. Impeller surfaces protected with Belzona® 1341 and Belzona® 1321 applied to wear ring and machined to size.
