POWER COMPANY APPROVES THE BELZONA SOLUTION

ID: 1085

Industry: Power
Application: CEP-Centrifugal Pumps
Substrate: Bronze
Products: * Belzona® 1321 (Ceramic S Metal) ,
* Belzona® 1341 (Supermetalglide) ,

Customer Location: Nuclear Power Plant, France
Application Date: January 2007

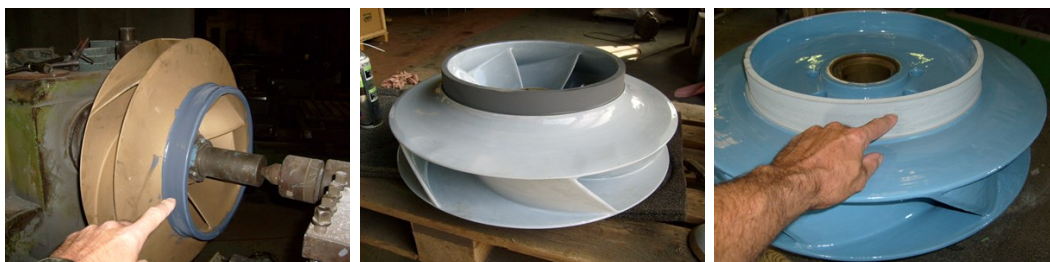
Photograph Descriptions

Erosion-Corrosion caused by sea water.

- * Commencement of application with Belzona® 1321 applied to wear ring ,
- * Application of the first coat of Belzona® 1341 ,
- * Completed application with wear ring machined to size ,

Application carried out in accordance with Belzona System Leaflet CEP-3. Impeller surfaces protected with Belzona® 1341 and Belzona® 1321 applied to wear ring and machined to size.

Based on previous experience, the power company approved the application for a further 6000 hours in service.
