# BELZONA STANDS THE TEST OF TIME

ID: 1180

**Industry:** Chemical & Petrochemical  
**Application:** HEX-Heat Exchangers  
**Substrate:** Carbon steel sheet, copper tubing  
**Products:** \* Belzona® 1111 (Super-Metal) ,  
 \* Belzona® 1321 (Ceramic S-Metal) ,

**Customer Location:** Petrochemical Plant, Louisiana U.S.A.  
**Application Date:** September 2003, September 2008

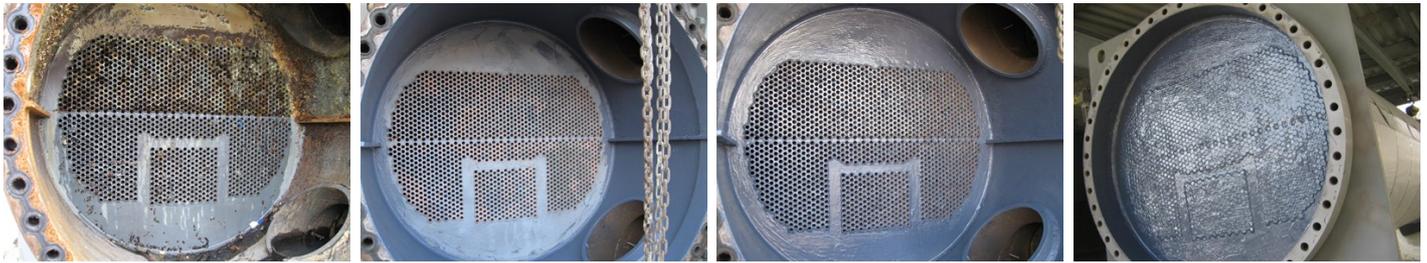
Tube sheet was suffering from bi-metallic corrosion and channel box was suffering from erosion/corrosion.

- \* Bi-metallic corrosion tube sheet ,
- \* Existing Belzona repaired blasted and channel box coated for first time ,
- \* Fully restored tube sheet with second application of Belzona ,
- \* Rear of chiller shown fully corked and coated, waiting for corks to be removed ,

Rebuild and protect the tube sheets on the faces of chiller. Also returned five years later for customer to inspect and to coat the channel box and baffle.

The application was carried out in accordance with Belzona Know-How System Leaflet HEX-1, HEX-2 & HEX-3.

The unit was one of three identical units at this facility. Once opened, the customer was satisfied with the performance of the Belzona coating and allowed a second application on the "sister" unit. The customer also allowed for the channel boxes to be coated, and for the existing tube sheet to be coated with another layer of Belzona® 1321. This application will extend the life of both chillers for many years, and saved the customer \$275,000 per unit in replacement costs.
