# BELZONA SEALS 20,000sq.ft.CONTAINMENT AREA

ID: 1201

Application: TCC-Tanks and Chemical Containment Areas

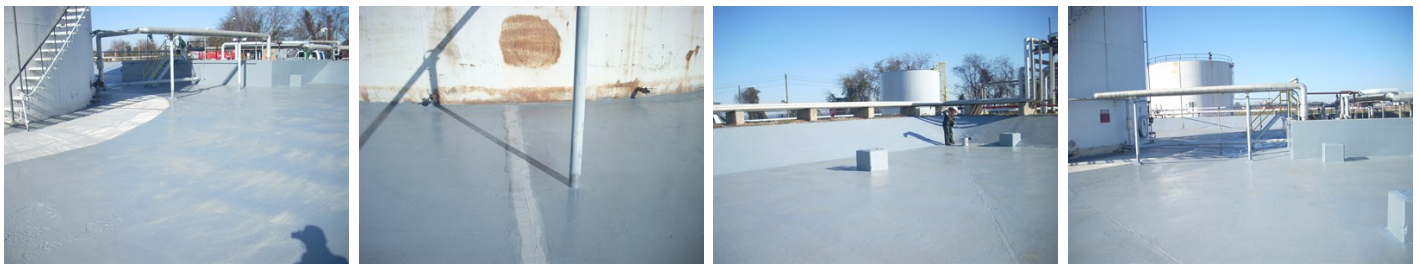
## Photograph Descriptions

Cracks and failed coating over the concrete dyke.

\* Over view of the containment area , \* Close up of the expansion joints , \* 2nd coat of Belzona® 5811 applied , \* Application completed with final coat of Belzona® 5111 ,

Application was carried out using a modified Belzona Know-How System Leaflet TCC-15. The concrete was high Pressure Water Jetted to remove loose coating and expansion joint sealant. Joints then sealed with Belzona® 4521. 2 coats of Belzona® 5811 and a top coat of Belzona® 5111 for UV Protection applied to entire area.
