SCREED BOX MAKES SCREEDING WITH BELZONA EASIER

Customer Location: *Pipe Mill, Alabama USA*

Application: *FPA-Floor Problem Areas*

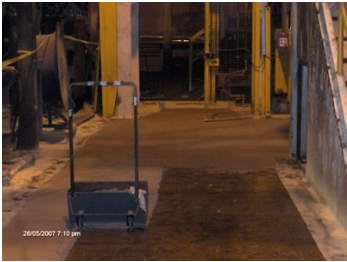
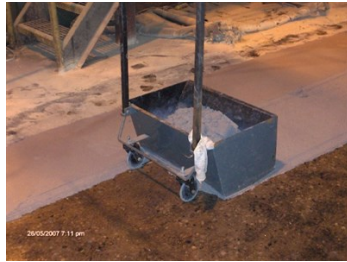
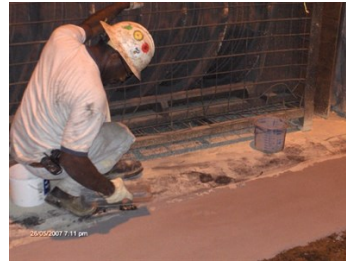
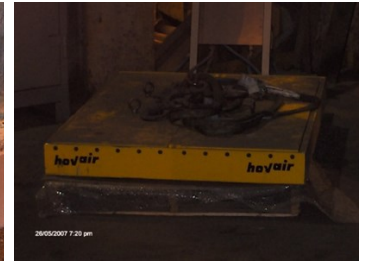
Photograph Descriptions

Old coating needed removing and the floor recoating. The floor had to be level for the air pallet jack to work properly.

* Application to the floor starting after completing surface preparation , * Close up of the screed box , * Applying the Belzona® 4131 in strips and troweling smooth , * Air pallet jack going over the Belzona® 4131 ,

An air pallet jack was losing its seal when going across the floor.

Application was carried out in accordance with Belzona Know-How System Leaflets FPA-1, -5 & -6. Screed box was used to install Belzona® 4131 at 1/4 inch over the entire floor. The expansion joint was sealed flush with the floor using Belzona® 2221.
