BELZONA PROTECTS CAUSTIC CONTAINMENT AREA

ID: 1206

Industry: Power
Application: TCC-Tanks and Chemical Containment Areas
Substrate: Concrete
Products: Belzona® 5811 (Immersion Grade)

Customer Location: Power Plant, Alabama USA
Application Date: December 2007

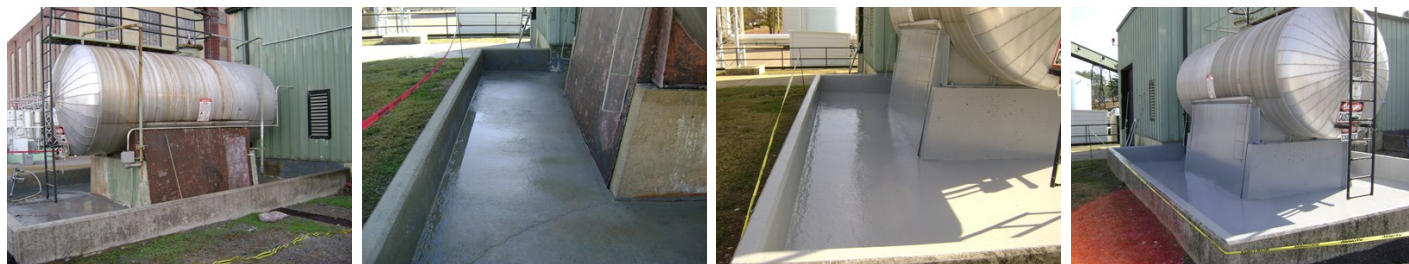
Photograph Descriptions

Customers Caustic Containment Area coating had failed and needed a new impervious coating installed.

* Containment before old coating removed , * Containment after old coating removed , * & 4. Completed application ,

Application was carried out in accordance with Belzona Know-How System Leaflet TCC-15. Old coating was removed using high pressure water blasting. Belzona® 5811 was applied to both containment and tank stands.
