BELZONA 4181 TAKES THE HEAT

Customer Location: Chemical plant, Memphis, Tennessee
U.S.A.

Application: TCC-Tanks and Chemical Containment
Areas

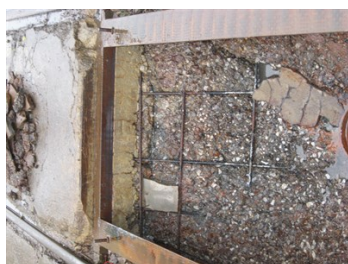
Concrete was eroding away due to steam and chemical wash downs.

- * Overview of the rail car unloading station ,
- * Eroded concrete in the sump ,
- * Belzona® 4181 being troweled onto the concrete surface ,

Previous grouts and coatings had failed due to the steam and hot water. Belzona® 4181 provides outstanding resistance to the chemicals and heat in this environment.
