# EVAPORATOR BARREL PROTECTION WITH BELZONA

ID: 1264

Creating a secondary containment barrier around an evaporator in need of replacement. Tobacco processing company.

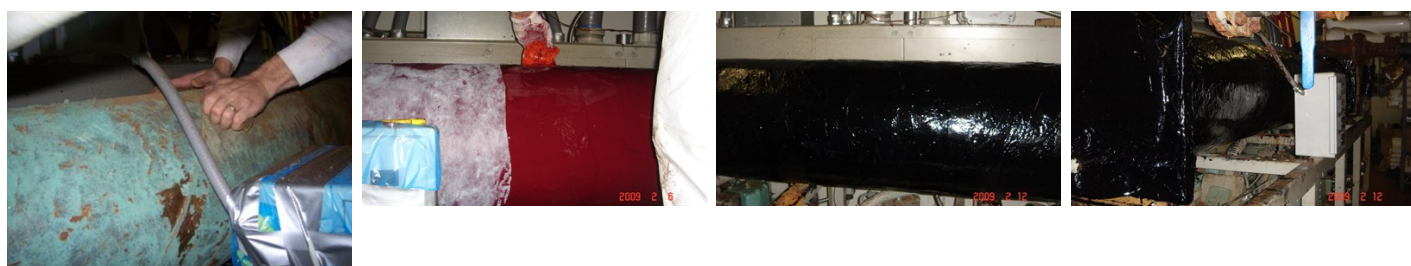
- \* Preparation of the barrel ,
- \* Application of the first coat and reinforcing sheet ,
- \* Completed application of second coat ,
- \* Completed application ,

The application was carried out with a modified version of Belzona Know-How System Leaflet. An orbital sander with a scotch brite pad was used to lightly abrade the surface, which was too thin to achieve an ideal preparation. The surface was cleaned with MEK. A heavy coat of Belzona 2121 was applied, the barrel was wrapped with Belzona 9331 and a second heavy coat of Belzona 2121 was applied.
