# FLOW CONTROL VALVE REFURBISHED WITH BELZONA

ID: 1276

Customer Location: WasteWater Plant, Jordan

85cm diameter control valve at the biggest wastewater treatment plant in Jordan.

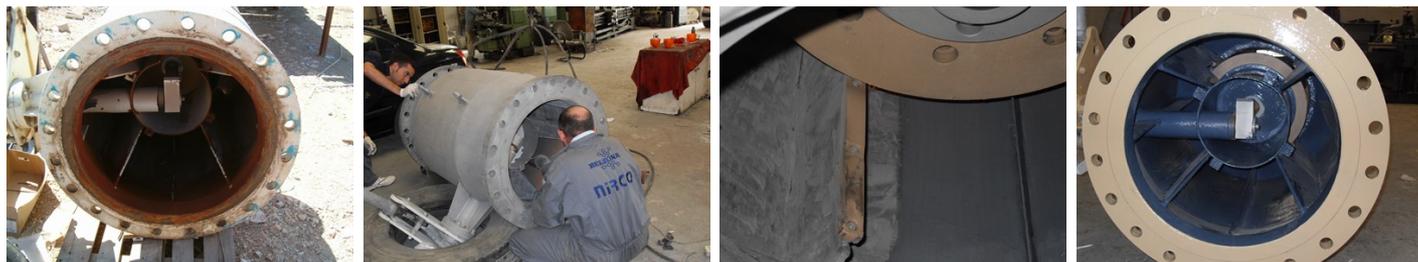
Corrosion and erosion on internal surfaces caused by sewage water.

\* General view of the valve , \* Rebuilding internal surfaces , \* Internal surfaces rebuilt and half coated , \* Valve coated internally and externally ,

Application was carried out in accordance with Belzona Know-How System Leaflets CEP-3, -4 and -5.
