# BELZONA STANDARD PROTECTION OF SCREW CONVEYOR FOR SOAP PRODUCTION

Industry: General Industry  
Application: SHM-Solids Handling Machinery

Customer Location: Soap and Detergent Producer, Bulgaria  
Application Date: September, 2008

Substrate: Silumin (High strength Aluminum alloy with Silicon)  
Products: \* Belzona® 1111 (Super Metal) ,  
\* Belzona® 1392 (Ceramic HT2) ,

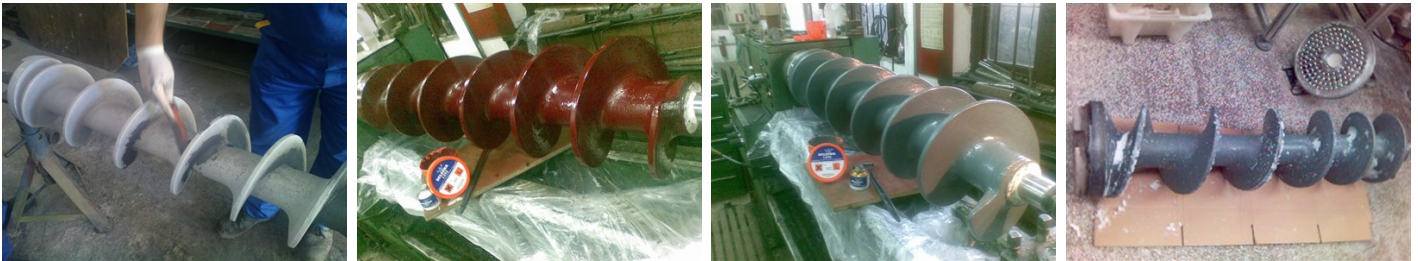
Erosion/corrosion causes pitting damage on screw conveyor surface accentuated by the high working temperatures (more than 60°C), high pressure injection and corrosive chemical process media.

- \* Surface damages repaired with Belzona® 1111 ,
- \* First coat of Belzona® 1392 (red) completed ,
- \* Second coat of Belzona® 1392 (grey) completed ,
- \* Inspection of screw after two months in working conditions ,

Application was carried out in accordance with Belzona Know-How System Leaflet SHM-14. Surface preparation was made in accordance with the Colgate-Palmolive procedure in Belzona approvals (Refurbishing and Coating Silumin Worms for Soap Plodders).

Two screw conveyors with OD 250 mm and 300 mm were protected with a third to be completed. Inspection review twomonths after application revealed only slight discolouring and loss of gloss. Belzona is routinely specified by this International soap producer for protection of these screws.
