BELZONA PROVIDES POSITIVE GRIP TO DRIVE ROLLER

ID: 1292

Customer Location: Fertilizer plant, Bulgaria

Application: SHM-Solids Handling Machinery

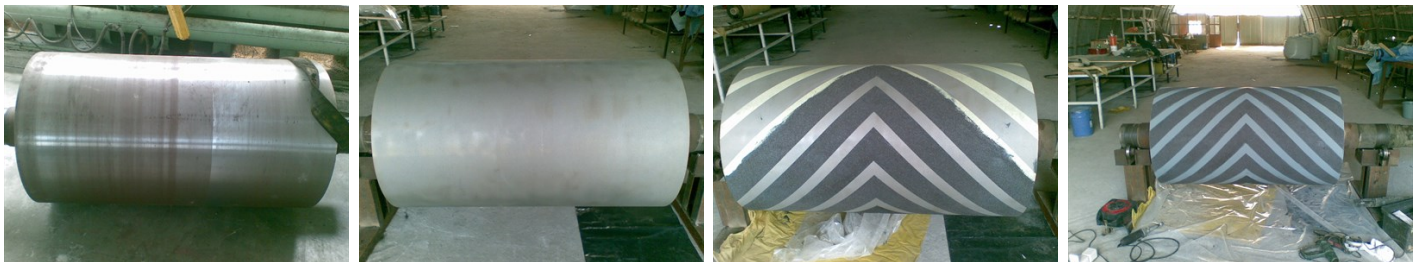
Photograph Descriptions

Pieces of rubber cladding were frequently torn away due to build up. In addition severe wear from excessive moisture, chemical attack and abrasive media was causing belt slippage.

- * Drive roller with just removed old rubber cladding ,
- * Grit blasted drive roller ,
- * Belzona non-slip chevron designed surface being applied ,
- * Completed application and drive roller ready for service ,

Application was carried out in accordance with Belzona Know-How System Leaflet SHM-12. Belzona 9211 non-slip aggregate was embedded in chevron designed stripes coated with Belzona® 1321. For corrosion protection the rest non-protected areas were covered with Belzona® 3921.

The whole application was completed in one working day for a fraction of the cost of conventional rubber cladding. The durable positive grip system eliminated belt slippage and protected drive roller from abrasion and corrosion. Similar Belzona positive grip
