INVISIBLE BELZONA PROTECTION FOR CHAPEL

ID: 1298

Parapet Walls on Crematorium Chapel of Remembrance

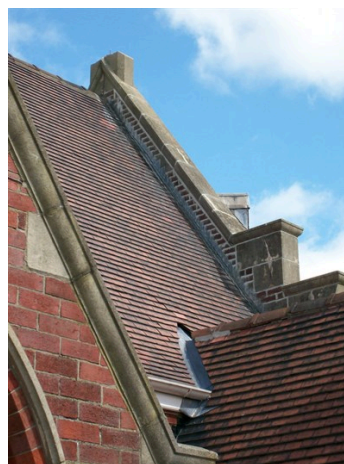
Aging mortar for masonry and brickwork had become porous. Water was persistently penetrating the structure, creating damp areas on internal walls. The Council wished to retain the original appearance of the structure.

- * Chapel of Remembrance - Front ,
- * Chapel of Remembrance - Rear ,
- * Parapet Wall Sections Protected with Belzona® 5122 ,
- * ,

Application was carried out in accordance with Belzona Know-How System Leaflet WPA-8. Once the brickwork had been repointed, all parapet wall areas were protected with a single coat of Belzona® 5122.

The contractor has used Belzona repeatedly to offer premium weather protection on porous masonry. Belzona® 5122 offered water repellent surface which was ideal for this building where they required to retain a natural look to the masonry surface.
