# BELZONA KEEPS HISTORY MOVING

ID: 1304

**Industry:** Transport  
**Application:** GSS-Gaskets, Seals and Shims  
**Substrate:** Cast Aluminium and Cast Iron.  
**Products:** \* Belzona 1111 (Super Metal) ,

Shimming of Mounting Plates

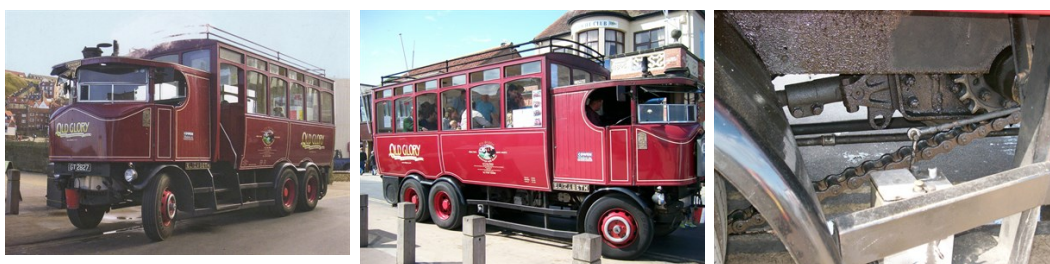
A carriage company operated the last steam driven bus in the world. "Elizabeth" is a 1931 Sentinel DG6P steam bus, which has been offering charabanc rides around the streets of Whitby since 2005. The steam engine generates a huge amount of vibration which accelerates the rate of wear on all engine parts. In this case, the aluminium face of cast mounting plates had been heavily damaged by the vibration of the cast iron sections of the engine.

- \* Sentinel Steam Bus "Elizabeth" recently refurbished ,
- \* "Elizabeth" taking tourists around Whitby ,
- \* Right hand side mounting plates refitted ,

The client has used Belzona repeatedly for repairs to various areas around the engine and undercarriage. In this application, Belzona 1111 had been used to create a shim between the engine mounting plates, which were cast iron and aluminium. By using Belzona as a shim, the client was able to avoid having to remake expensive specialised replacement parts. In addition, by recreating a secure mounting interface with 100% intermit contact, further wear is almost totally avoided. The client continues to use Belzona to keep this historic vehicle running.
