# BELZONA PROTECTS NEWLY CONSTRUCTED CONTAINMENT AREA

ID: 1338

**Industry:** Chemical & Petrochemical  
**Application:** TCC-Tanks and Chemical Containment Areas

**Customer Location:** Petrochemical Plant, Canada  
**Application Date:** October 2007

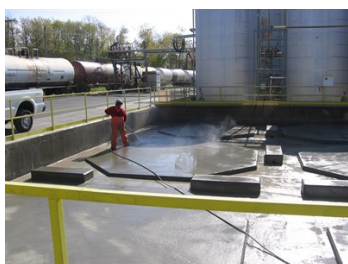
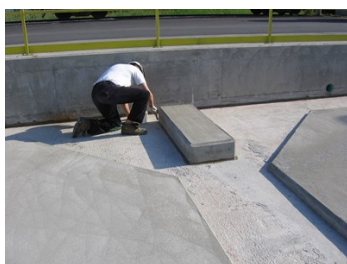
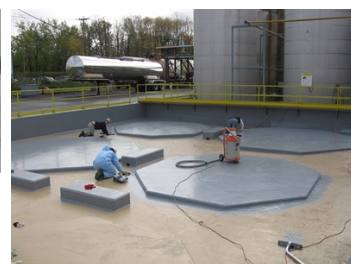
## Photograph Descriptions

- \* Surface preparation with high pressure wash ,
- \* Application of Belzona® 4911 Conditioner ,
- \* Application of Belzona® 4111 to create a fillet on wall/floor junctions. ,
- \* Application of Belzona® 5811 (beige and grey colors used) ,

Application carried out in accordance with Belzona Know-How System leaflet TCC-15.

Belzona® 5811 provides excellent resistance to broad range of chemicals (Alums and Hydrochloric acid in this case). Use of beige and grey colors ensures good coverage and protection to the underlying concrete. Belzona® 4111 fillet provides additional security and potential problem areas such as the wall to floor joint.
