BELZONA PROTECTS NEWLY CONSTRUCTED CONTAINMENT AREA

ID: 1338

Industry: Chemical & Petrochemical
Application: TCC-Tanks and Chemical Containment Areas

Customer Location: Petrochemical Plant, Canada
Application Date: October 2007

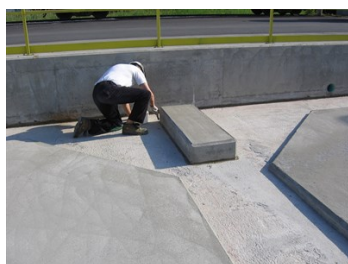
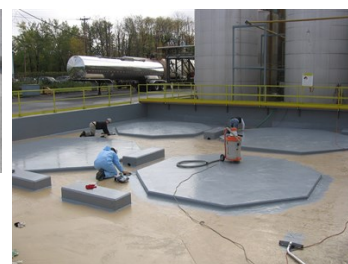
Photograph Descriptions

- * Surface preparation with high pressure wash ,
- * Application of Belzona® 4911 Conditioner ,
- * Application of Belzona® 4111 to create a fillet on wall/floor junctions. ,
- * Application of Belzona® 5811 (beige and grey colors used) ,

Belzona® 5811 provides excellent resistance to broad range of chemicals (Alums and Hydrochloric acid in this case). Use of beige and grey colors ensures good coverage and protection to the underlying concrete. Belzona® 4111 fillet provides additional security and potential problem areas such as the wall to floor joint.
