BELZONA PREPARES VERTICAL PUMP FOR ACID SERVICE

Industry: Oil & Gas
Application: CEP-Centrifugal Pumps
Substrate: Cast Iron
Products: * Belzona® 1111 (Supermetal) ,
 * Belzona® 4311 (Magma CR1) ,

Customer Location: Refinery, Canada
Application Date: May 2005

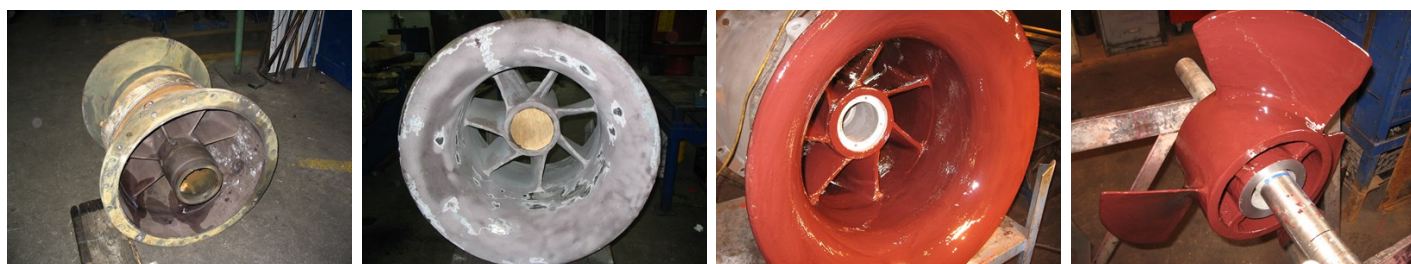
Photograph Descriptions

Chemical attack inside volute and on the impeller.

- * Original pump after 5 years ,
- * The volute after surface preparation ,
- * The volute after coating with Belzona® 4311 ,
- * The impeller protected with Belzona® 4311 ,

Vertical pumps to handle sulfuric acid

Application was carried out in accordance with Belzona System leaflet CEP-3.

Belzona 4311, designed to withstand immersion in such aggressive chemicals, once more proved that it is a very cost effective maintenance solution for equipment.
