STRESS FREE SEALING OF THREADED PIPES WITH BELZONA

ID: 1342

Customer Location: Telecom company, Montreal, Canada
Application Date: October 2008

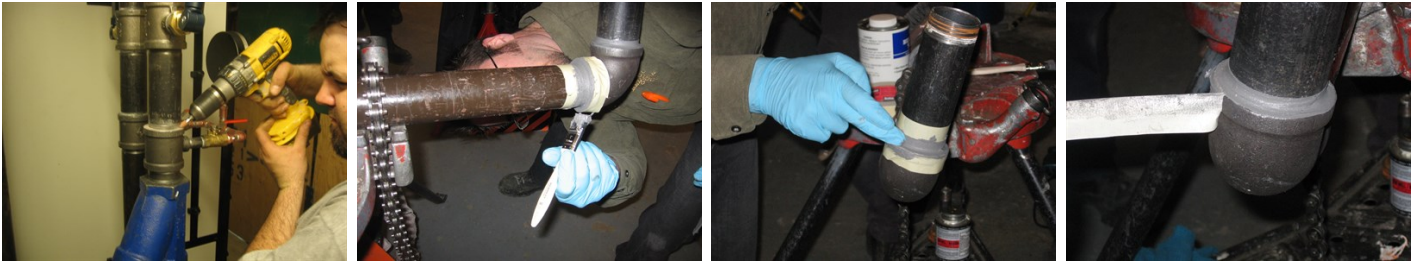
Photograph Descriptions

- * Surface preparation of pipe ,
- * Application of Belzona® 1121 with brush ,
- * Finishing the application neatly ,
- * Completed application ,

Sealing threaded pipe joints.

Application was carried out in accordance with a modified Belzona Know-How System Leaflet VPF-11 created and approved by both parties.

Due to the expensive equipment in place the customer wanted a top solution for the sealing of threaded pipes. Traditional welding was not an option. The application of Belzona provided excellent sealing without heat. This solution caused no stress cracking and gave extra protection on the threaded joints. Client has now approved this Belzona application.
