# STRESS FREE SEALING OF THREADED PIPES WITH BELZONA

ID: 1342

**Industry:** General Industry  
**Application:** VPF-Valves, Pipes and Fittings  
**Substrate:** Cast iron and mild steel  
**Products:** \* Belzona® 1121 (Super XL Metal) ,

**Customer Location:** Telecom company, Montreal, Canada  
**Application Date:** October 2008

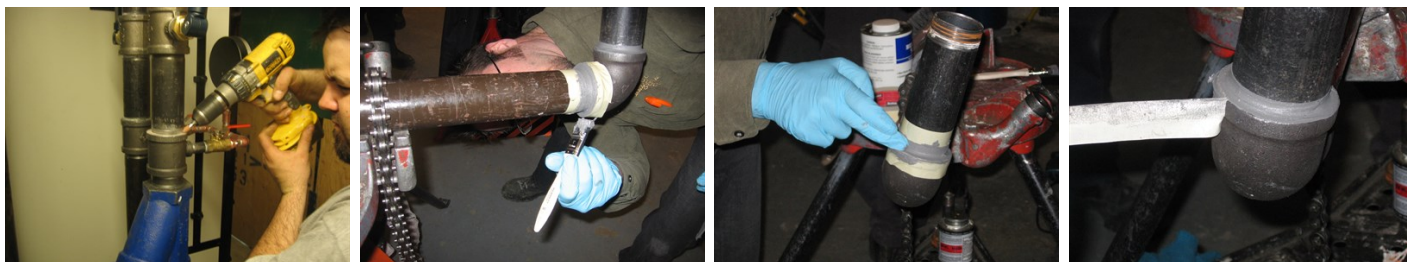
## Photograph Descriptions

- \* Surface preparation of pipe ,
- \* Application of Belzona® 1121 with brush ,
- \* Finishing the application neatly ,
- \* Completed application ,

Sealing threaded pipe joints.

Application was carried out in accordance with a modified Belzona Know-How System Leaflet VPF-11 created and approved by both parties.

Due to the expensive equipment in place the customer wanted a top solution for the sealing of threaded pipes. Traditional welding was not an option. The application of Belzona provided excellent sealing without heat. This solution caused no stress cracking and gave extra protection on the threaded joints. Client has now approved this Belzona application.
