BELZONA MAINTAINS THE FLOW

Industry: *Pulp & Paper*
Application: *CEP-Centrifugal Pumps*
Substrate: *Cast Iron*
Products: ** Belzona® 1341 (Supermetalgilde) ,*

Customer Location: *Paper Mill, Ontario*
Application Date: *April, 2009*

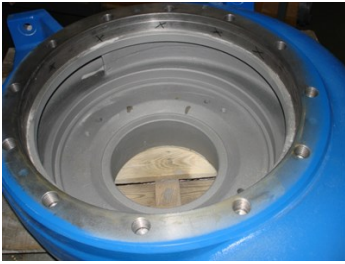
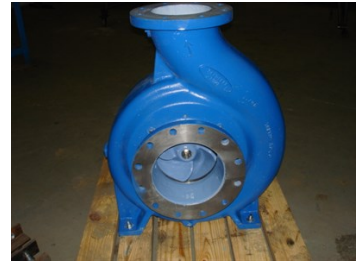
- * 1 & 2 Internal surfaces grit blasted ,
- * 3. Belzona 1341 applied ,
- * 4. Completed application ,

Application was carried out in accordance with Belzona Know-How System Leaflet CEP-3. Casing and impeller were blasted to achieve a 3 mil profile and 2 coats of Belzona® 1341 were applied.

The smooth hydrophobic surface of the Belzona® 1341 has reduced the amount of Aluminum Sulfate build up on this customers pump.
