# BELZONA MAINTAINS THE FLOW

ID: 1344

Application: CEP-Centrifugal Pumps

Customer Location: Paper Mill, Ontario

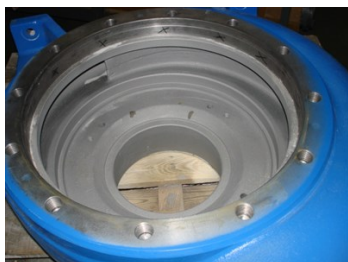
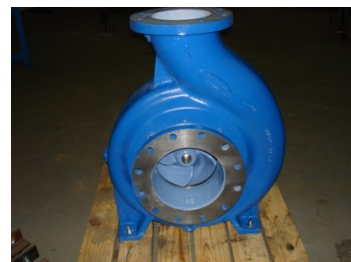
- \* 1 & 2 Internal surfaces grit blasted ,
- \* 3. Belzona 1341 applied ,
- \* 4. Completed application ,

Application was carried out in accordance with Belzona Know-How System Leaflet CEP-3. Casing and impeller were blasted to achieve a 3 mil profile and 2 coats of Belzona® 1341 were applied.
