BELZONA MAINTAINS THE FLOW

Industry: *Pulp & Paper*
Application: *CEP-Centrifugal Pumps*
Substrate: *Cast Iron*
Products: ** Belzona® 1341 (Supermetalgilde) ,*

Customer Location: *Paper Mill, Ontario*
Application Date: *April, 2009*

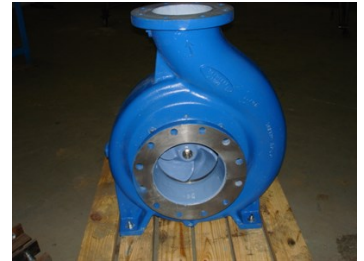
Customer was looking for a way to reduce Aluminium Sulfate build-up that they had experienced on their previous pump.

- * 1 & 2 Internal surfaces grit blasted ,
- * 3. Belzona 1341 applied ,
- * 4. Completed application ,

Application was carried out in accordance with Belzona Know-How System Leaflet CEP-3. Casing and impeller were blasted to achieve a 3 mil profile and 2 coats of Belzona® 1341 were applied.

The smooth hydrophobic surface of the Belzona® 1341 has reduced the amount of Aluminum Sulfate build up on this customers pump.
