# PUMP BELL CASING REPAIRED AND PROTECTED WITH A LONG TERM BELZONA SOLUTION

Industry: Power  
Application: CEP-Centrifugal Pumps  
Substrate: Cast Iron  
Products: \* Belzona® 1311 (Ceramic R-Metal) ,  
\* Belzona® 1321 (Ceramic S-Metal) ,  
\* Belzona® 5811 (Immersion Grade) ,

Customer Location: National Electricity Provider, Malta  
Application Date: May 2000

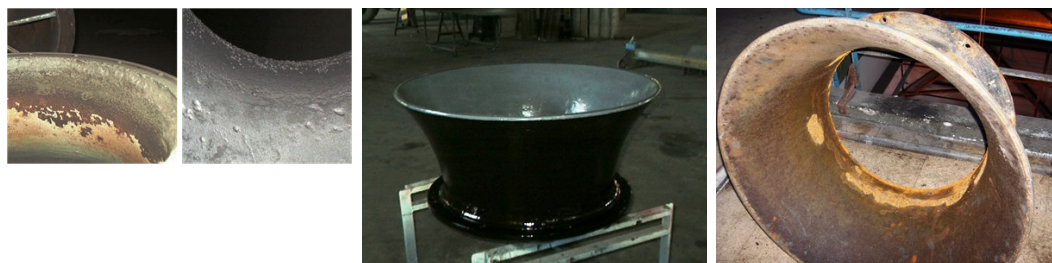
Efficiency losses and pump breakdown due to severe erosion-corrosion of the single vertical axial flow pump (7090 m<sup>3</sup>/h). Prior to the Belzona solution the client had to replace or repair the pump components annually. As a significant local electricity supplier, downtime of this critical equipment caused major problems.

- \* Original system after 1 year in service ,
- \* The finished Belzona application ,
- \* Cavitation damage in the swept area ,
- \* Ready to go back into service after touch up ,

The original bell lining was failing on an annual basis, leading to pitting corrosion and regular replacement. The Belzona repair vastly

improved reliability and performance. The pump casing, liner and diffuser were also repaired and coated, internally and externally. Yearly touch up is required of the sacrificial coating in the swept area due to cavitation damage. original Belzona protected bellmouth still in service after nine years.
