# BELZONA ELIMINATES BREACHES IN BLAST FURNACE

ID: 1371

Customer Location: Steel Manufacturer, Teesside, UK  
Application Date: October 2009

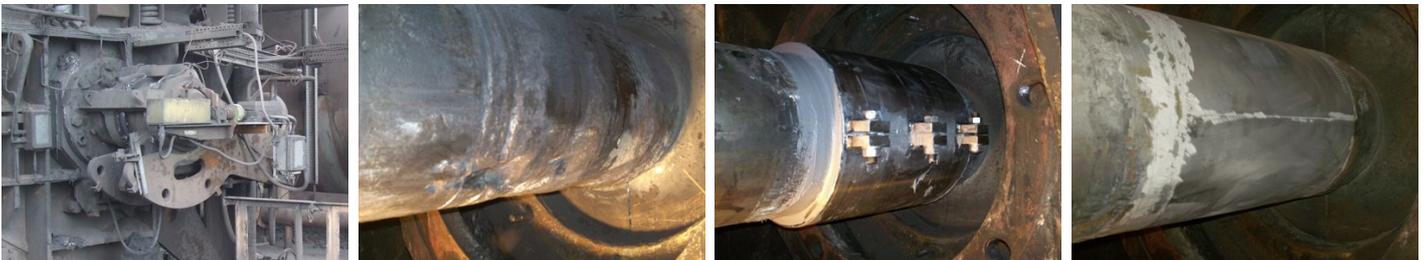
Abrasive dust and gases from the blast furnace had bypassed packings and seals around the shaft for the flow control gate at the top of the blast furnace. Damage had rapidly escalated, creating several grooved rings and severely gouged pits up to 15mm deep, allowing gases to escape, creating a potentially toxic area.

- \* Blast Furnace Flow Control Gate assembled ,
- \* Damaged shaft ,
- \* Application of Belzona® 1111 and clamp former ,
- \* Final dressing of Belzona® 1111 before reassembly ,

The contractor completed the work throughout the night and under a tight schedule. 9Kg of Belzona® 1111 was used with a purpose built clamp to recreate the original shaft profile of 280mm diameter. The preparation and application took only 2.5 hours, followed by a 5 hour cure period using heating pads to accelerate the cure. The blast furnace was returned to service with minimum downtime and to the complete satisfaction of the client.
