BELZONA PROTECTS AMINE STRIPPER COLUMN

Customer Location: Petrochemical Company, Egypt

Application: TCC-Tanks and Chemical Containment Areas

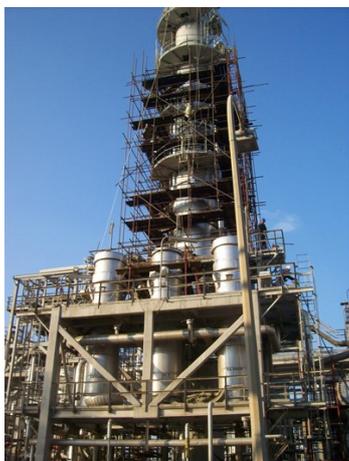
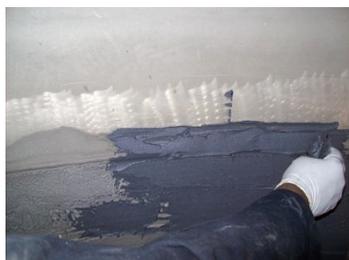
Photograph Descriptions

Corrosion had led to a reduction in the wall thickness, forcing a shutdown.

* 1. General view of the column 2. Application of Belzona 1511 to grit blasted substrate 3. Finished application after pinhole inspection 4. Inspection after 3 years service. ,

Belzona offered a corrosion resistant system for the hot chemical process involved. Metal cladding could not be carried out within the time constraints of this short shutdown. Inspection after 3 years service showed the coating to be in excellent condition.
