# BELZONA PROTECTS AMINE STRIPPER COLUMN

ID: 1416

**Customer Location:** Petrochemical Company, Egypt

**Application:** TCC-Tanks and Chemical Containment Areas

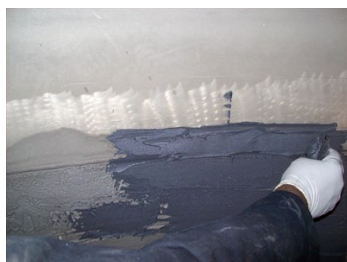
Corrosion had led to a reduction in the wall thickness, forcing a shutdown.

\* 1. General view of the column 2. Application of Belzona 1511 to grit blasted substrate 3. Finished application after pinhole inspection 4. Inspection after 3 years service. ,

Belzona offered a corrosion resistant system for the hot chemical process involved. Metal cladding could not be carried out within the time constraints of this short shutdown. Inspection after 3 years service showed the coating to be in excellent condition.
