BELZONA EXTENDS LIFE OF MIXER BOWLS FROM ENGINE CASTING PLANT

ID: 1421

Application: SHM-Solids Handling Machinery

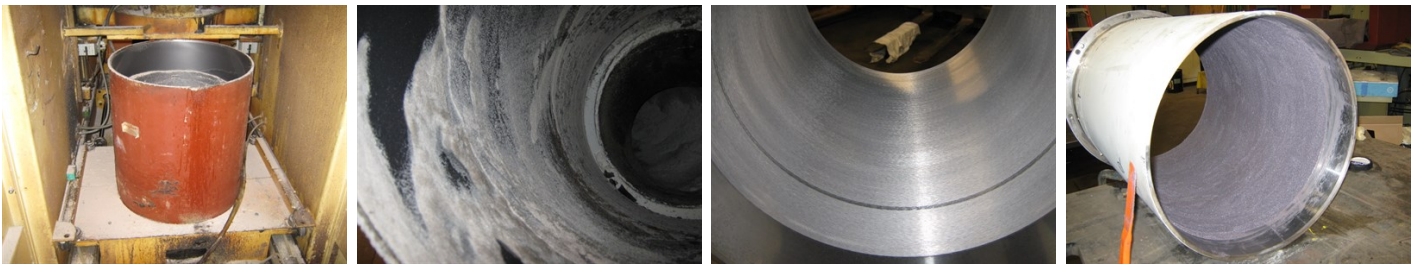
Photograph Descriptions

Inside surface of bowl was being eroded by the sand mixture. The bowl measures approximately 19 inches in diameter by 27 inches in length. The inner surface was being eroded by 1/4 inch during a 6 month period. The mixers handle up to 5.5 tonnes of sand per hour.

- * Working mixer bowl ,
- * Inner bore of worn mixer ,
- * New mixer bowl after machining ,
- * Completed application of Belzona® 1812 ,

Application was carried out in accordance with Belzona Know-How System Leaflet SHM-13. The inner surface was machined to remove approximately 3/16 of an inch of material to allow for build up of Belzona® 1812 which was applied by hand using top flange and lower wear plate to control thickness.

Customer had previously tried welding 8 inches of bowl length with Tungsten at a cost of \$9000. With Belzona they were able to repair the full stroke length of 24 inches in the mixer for \$5400. Each bowl is estimated to cost \$13000. Bowls that were normally lasting less than 6 months have lasted 18 months with only minor repair to the Belzona lining required.
