BELZONA PROVIDES LONG TERM PROTECTION OF OBSERVATORY ROOF

ID: 1447

Customer Location: Mills Observatory, Dundee Scotland

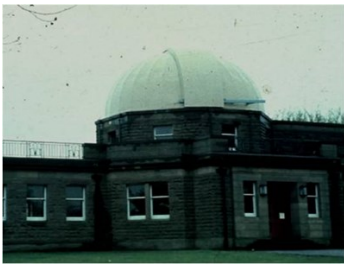
The domed roof of the Observatory was suffering severe maintenance problems caused by water ingress into the delicate dome structure.

- * Original Application in 1974 ,
- * Refurbishment in 1988 ,
- * Application revisited in 2010 ,
- * Application revisited in 2010 still in perfect condition ,

A fully reinforced Belzona® 3111 System was originally applied in 1974. Following this original Belzona application, the roof was refurbished in 1988 with a single layer of Belzona® 3111 to assure complete weatherproofing for future years. To provide enhanced appearance Belzona® 5151 was applied in 2003.

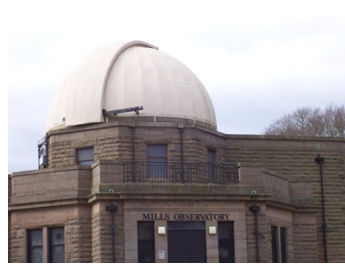
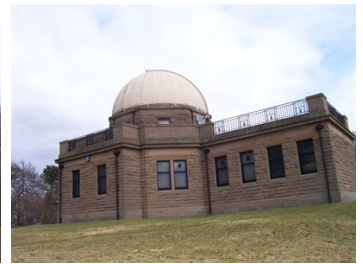
The application was revisited again in 2010 still showing that the application was in perfect condition. The self cleaning properties of Belzona® 5151 continue to maintain the excellent appearance of the roof.
