# BELZONA CUI SOLUTION

ID: 1451

Customer Location: Oil Company, Bohai Bay, China  
Application Date: January, 2007

Corrosion under Insulation

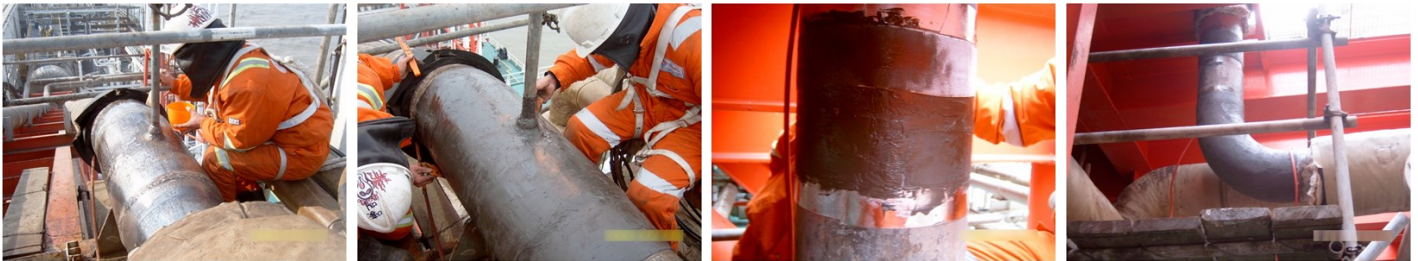
## Photograph Descriptions

- \* Surface preparation ,
- \* Applying Belzona® 1251 ,
- \* Wrapping with Belzona® 9341 reinforcement tape ,
- \* Completed work ,

Oil and hot water pipelines on deck area of offshore platform

Application carried out in accordance with Belzona Know-How System VPF-11a. After surface preparation, Belzona® 1251 with Belzona® 9341 (Reinforcement Tape) used to wrap and encapsulate the pipework.
