BELZONA ENHANCES EFFICIENCY OF NEW PUMPS

Industry: Water / Wastewater
Application: CEP-Centrifugal Pumps
Substrate: Cast iron case and bronze impeller
Products: * Belzona® 1111 (Super Metal) ,
* Belzona® 1341 (Supermetalgilde) ,

Customer Location: Water supply company, Bulgaria
Application Date: February - April, 2010

New double end suction centrifugal Worthington pump

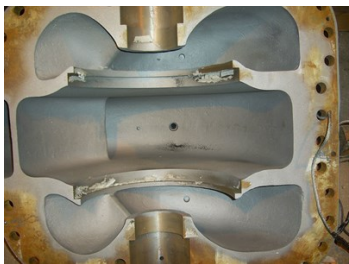
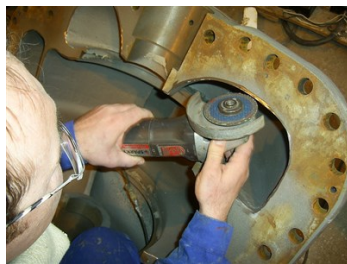
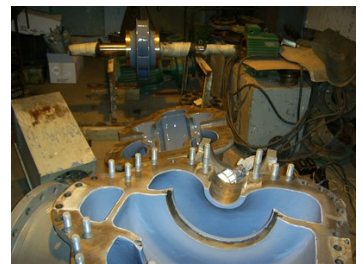
Photograph Descriptions

- * Grit blasted casing ,
- * Preparation of rebate grooves ,
- * First coat of Belzona® 1341 applied ,
- * Finished application with second coat of Belzona® 1341 ,

Application procedures were carried out in accordance with Belzona Know-How System Leaflets CEP-3 and CEP-10.

As a result of applied Belzona efficiency enhancement coating a reduced power consumption of 35 kWh was registered and efficiency was increased to 3.5% at duty point. Two new pumps were coated with Belzona during this application period.
