BELZONA ENHANCES EFFICIENCY OF NEW PUMPS

Industry: Water / Wastewater
Application: CEP-Centrifugal Pumps
Substrate: Cast iron case and bronze impeller
Products: * Belzona® 1111 (Super Metal) ,
* Belzona® 1341 (Supermetalgilde) ,

Customer Location: Water supply company, Bulgaria
Application Date: February - April, 2010

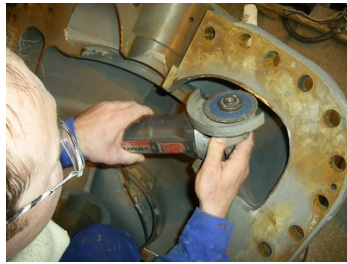
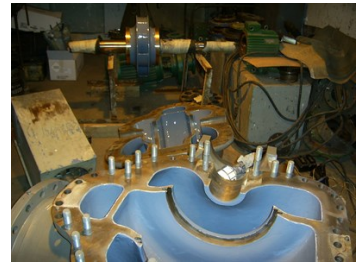
Photograph Descriptions

- * Grit blasted casing ,
- * Preparation of rebate grooves ,
- * First coat of Belzona® 1341 applied ,
- * Finished application with second coat of Belzona® 1341 ,

Application procedures were carried out in accordance with Belzona Know-How System Leaflets CEP-3 and CEP-10.

As a result of applied Belzona efficiency enhancement coating a reduced power consumption of 35 kWh was registered and efficiency was increased to 3.5% at duty point. Two new pumps were coated with Belzona during this application period.
