# BELZONA PROTECTS NEW HEAT EXCHANGERS

ID: 1516

Application: *HEX-Heat Exchangers*

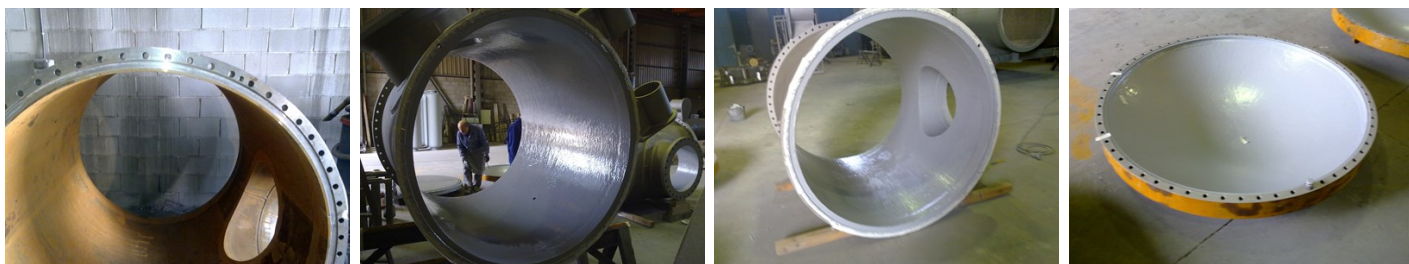
## Photograph Descriptions

- \* Part to be coated, before blasting ,
- \* Coating with Belzona® 5891 ,
- \* End heads coated with Belzona® 5891 ,
- \* Cover coated with Belzona® 5891 ,

The application was carried out in accordance with Belzona Know-How System Leaflet HEX-3.
