BELZONA BRIDGES A SLIPPERY PROBLEM

ID: 1570

Industry: *Buildings & Structures*
 Application: *FPA-Floor Problem Areas*
 Substrate: *Other*
 Products: *Belzona 4411 (Granogrip)*

Customer Location: *City of Paris, France*
 Application Date: *2000 & 2003*

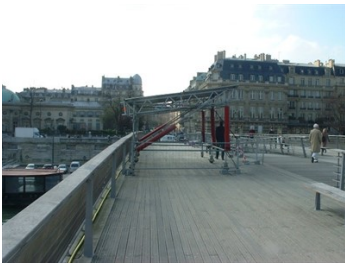
Non-disruptive application in 2000

The application was carried out using a modified version of Belzona Know-How System Leaflet FPA-8.

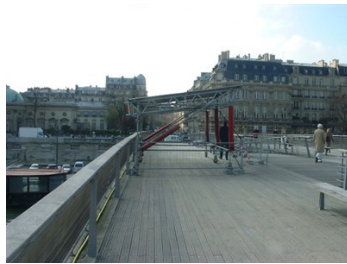
Non-disruptive application in 2000

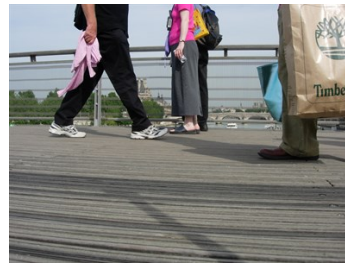
Users in 2005
