BELZONA PROOFING BOX FLOOR FOR SUPERMARKET

ID: 159

Application: FPA-Floor Problem Areas

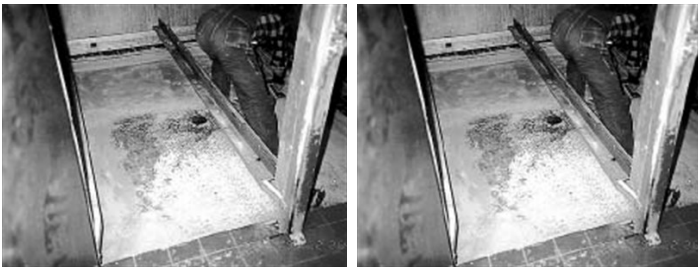
Photograph Descriptions

The proofing boxes in the bakeries is where bakery products are put to cause the dough to rise. Temperature is held at 100°F. Repairs required a U.S.D.A. approved food safe product.

- * Partial application showing damaged concrete ,
- * Completed application of proofing box ,

The application was carried out in accordance with Belzona Know-How Leaflet FPA-1.

These bakeries run 24 hours a day. One reason Belzona® 4111 was chosen is it has no offensive odor. The repair started around noon and finished by 2:00 p.m., allowing plenty of time for the Belzona® 4111 to cure before the next scheduled bakery shift at 2:00 a.m. the next morning. No odor was detected at 2:00 a.m. A total of 12 store proofing boxes were done.
