BELZONA PROVIDES LONG TERM SOLUTION FOR FGD REACTORS

Customer Location: Power Plant, North Dakota

Problem

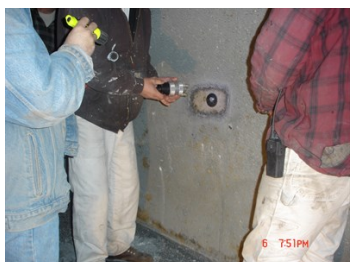
Reactor contains corrosive alkaline slurry of gypsum and lime. Coating required for corrosion protection.

- * Coating behind crust of slurry ,
- * Coating from 2000 application ,
- * Adhesion testing ,
- * Adhesion testing ,

The walls and floor were coated with Belzona® 5811. Due to higher temperatures ceiling and roof coated with Belzona® 5891. The applications have been carried out in stages over a 7 year period starting in 2000. Unit one was inspected in 2007 and found to be in excellent condition. Adhesion tests were performed on the walls of the reactor (oldest part of the coating) and found to exceed 1600 psi direct tension as per ASTM D4541.
