Belzona PROTECTS POTABLE WATER TANKS

ID: 1612

Customer Location: Shipyard, Mallorca, Spain

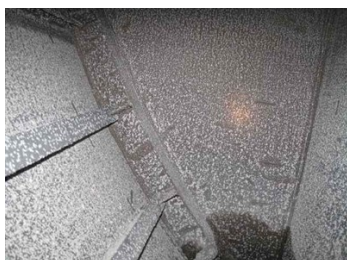
Two aluminium potable water tanks were suffering pitting corrosion that was decreasing the wall thickness. The substrate had to be protected with a potable water approved coating.

- * General view of the boat ,
- * Corrosion in the tank ,
- * Coating with Belzona[®] 5811DW ,
- * Final aspect after application ,

Belzona products safely protected the tanks from corrosion and allowed a fast and easy back to service with an in-situ application. This avoided replacement of the equipment, making significant cost savings.
