# BELZONA PROVIDES COST EFFECTIVE SOLUTION TO CONVEYOR BELT REPAIRS

ID: 1621

Application: *SHM-Solids Handling Machinery*

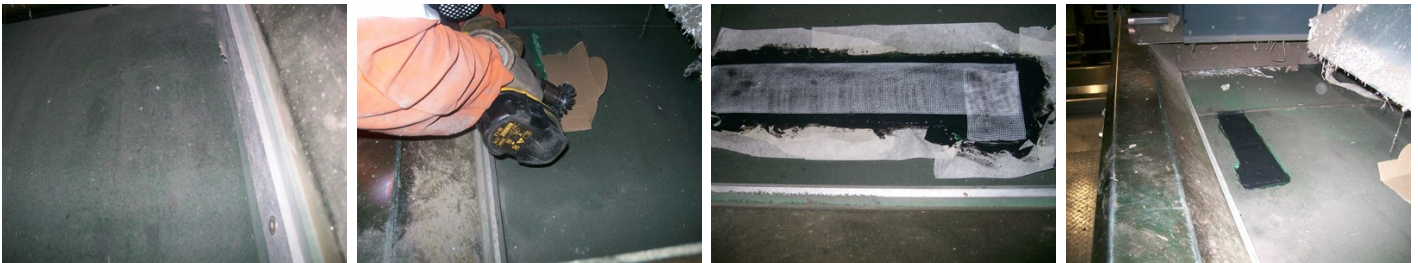
*An L shaped cut approximately 300mm across the length of the belt was found in a new conveyor belt.*

- \* Damaged conveyor belt - L shaped cut ,
- \* Surface being prepared using a wire brush on a hand drill ,
- \* Belzona Conditioner applied with 1 coat of product and reinforcing tape laid on top ,
- \* Completed conveyor repair ,

The application was carried out in accordance with Belzona Know-How system Leaflet SHM-1. Top cover was cut back before repairing with Belzona® 2311 incorporating Belzona® 9341 (Reinforcement Tape).
