# FOUR BELZONA REPAIRED CONDENSERS STILL IN SERVICE AFTER 17 YEARS

**Customer Location:** Power station, Thailand  
**Application Date:** October 1993

Four main condensers with a total of eight tube sheets

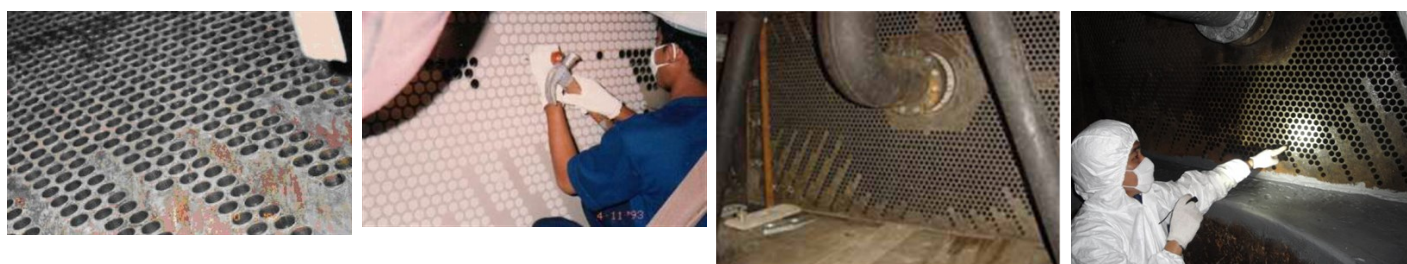
Corrosion pitting had occurred around the tubes as a result of bi-metallic corrosion effects and the chloride content of the used river water.

- \* Corroded tube sheet before application in 1993 ,
- \* Standard application underway. Special care was taken to prevent contamination of substrate) ,
- \* Inspection in 2005 ,
- \* Inspection in 2010 ,

The application was carried out in accordance with the Belzona Know-How System Leaflet HEX-1. Belzona® 1311 was used for rebuilding and Belzona® 1321 for the coating of the tube sheets.

Since the application of the coating, regular inspections took place which proved the excellent performance of the Belzona coating. In 2005, the complete coating of the tube sheet was still intact without showing any signs of degradation. A further inspection in 2010, after 17 years in service, also showed that the coating was still in a good condition. Only 10% of the surface was locally

damaged due to mechanical damage. These areas were quickly repaired with Belzona before the tube sheet was put back into service.
