BELZONA UPGRADES MORTUARY FLOOR

Customer Location: Hospital Mortuary, Glasgow
Application Date: March 2008

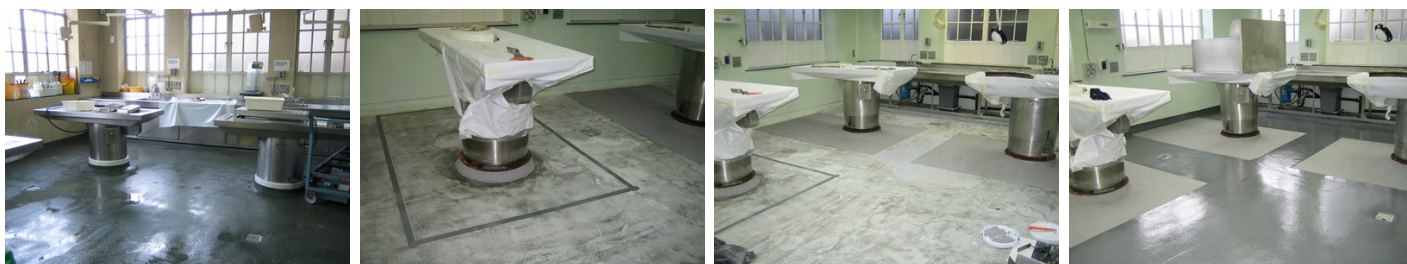
Photograph Descriptions

As the floor was regularly washed down, it had caused the floor to become damaged and uneven causing water to gather in certain areas.

- * Damaged floor ,
- * Examination table base screeded with Belzona® 4131 ,
- * Floor repairs using Belzona® 4131 ,
- * Completed application after application of Belzona® 5231 ,

The customer required the lifting of the existing floor system and repairing the damaged floor areas, followed by an over-coat of a positive grip system.

Application was carried out in accordance with Belzona Know-How System Leaflets FPA-1 & 8. The Belzona® 4131 was first applied for the repairs to the bases of examination tables, and following this, a dark grey Belzona® 5231 with 15% grey aggregate was applied to give the positive traction system the customer required.
