BELZONA KEEPS STUDENTS SAFE AT PRESTIGIOUS UNIVERSITY

ID: 1647

Industry: Buildings & Structures
Application: FPA-Floor Problem Areas
Substrate: Concrete
Products: * Belzona® 4411 (Granogrip) ,

Customer Location: University, UK
Application Date: March 2011

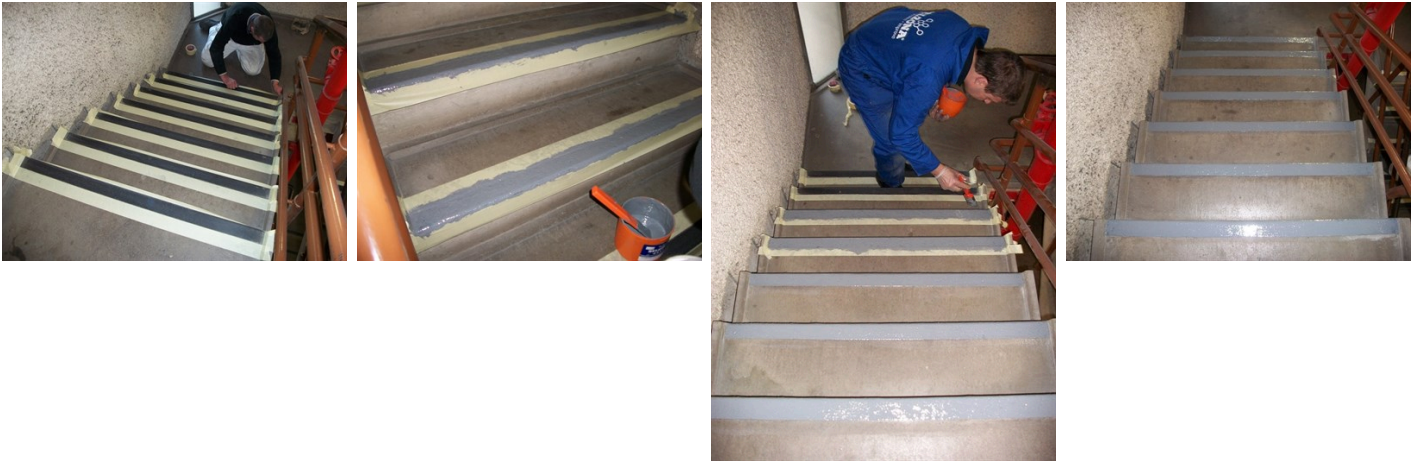
The existing grip system had worn away over the years.

* Safety Grip areas masked off Close up of the ongoing application Application in progress The application completed ,

Application was carried out in accordance with Belzona Know-How System Leaflet FPA-8.

This is a very high pedestrian area with 190 steps. They required a high performance positive grip system which would also be easy to clean. In addition, a fast curing system was required so that disruption was minimized.
