# Bomba 1000/700 Allen Gwynne protegida con Belzona

ID: 1695

Ubicación del cliente: Autoridad Local del Agua, Sudáfrica  
Fecha de aplicación: Julio 2006

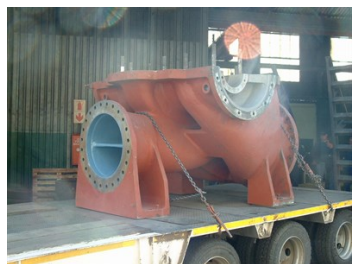
- \* Bomba llevada a OEM tras ser revestida ,
- \* Interior de la bomba ,
- \* Sección inferior de la bomba, 9 toneladas ,
- \* Sección de la bomba ,

La aplicación se llevó a cabo de acuerdo con el folleto Belzona de Sistema CEP-10.

Se aplicaron 40 Kg de Belzona® 1341 a la bomba. Ésta autoridad local del agua ha estandarizado Belzona® 1341 para todas sus bombas de agua.
