# BELZONA PROTECTS POWER STATION CHIMNEY STACK

Industry: Power  
Application: WPA-Wall Problem Areas  
Substrate: Concrete  
Products: \* Belzona® 5151 (Hi-Build Cladding) ,

Customer Location: Powerstation, Zambrow, Poland  
Application Date: 2004

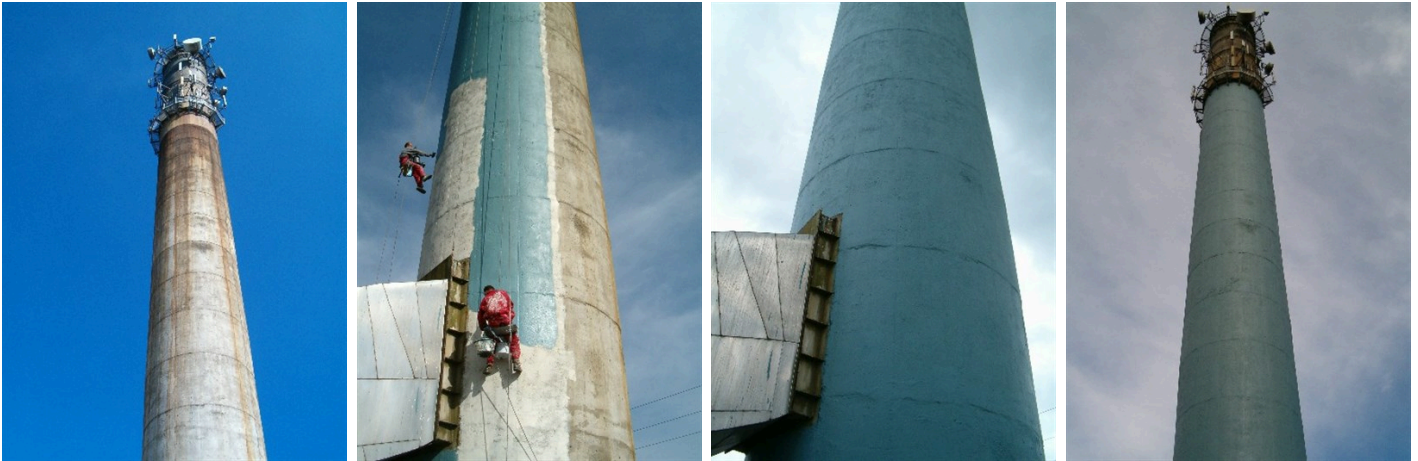
The concrete had become deteriorated from the locally generated fumes and required protection.

- \* Before application ,
- \* Application via rope access ,
- \* Close up of completed application ,
- \* General view of the protected stack ,

The application was carried out in accordance with a modified Belzona Know-How System Leaflet WPA-2. To reduce disruption Rope Access technicians were used to complete the application.

In this particular case, the client required a blue/grey coating to meet their corporate needs. The Belzona® 5151 was modified to

match the colours without deteriorating the performance of the coating which provides excellent protection whilst maintaining good appearance through its self cleaning properties.
