BELZONA BONDS PIPE SUPPORTS TO TANK

ID: 1720

Customer Location: Tank Farm, Dublin, Ireland
Application Date: December 2002

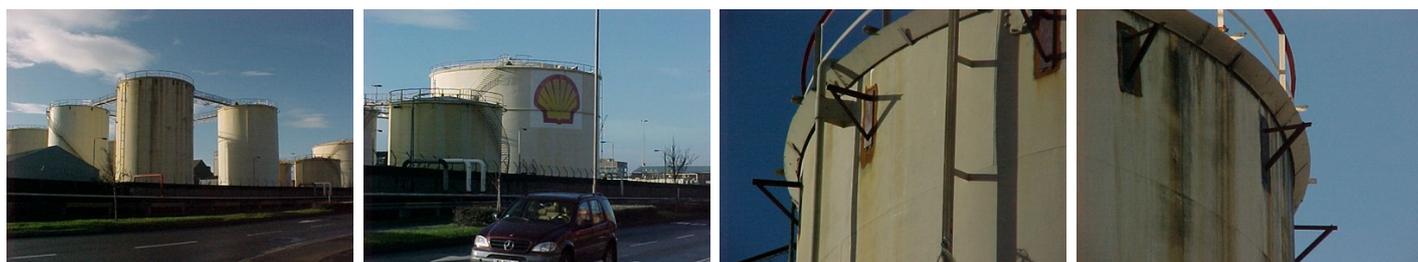
Photograph Descriptions

- * Tank Farm Location ,
- * Tank Farm Location ,
- * Close up showing the bracket bonded. The rust was due to the later coating of the tank/bracket ,
- * Additional view of bonded brackets ,

Application was carried out using a modified version of Belzona System Leaflet VPF-15. The surfaces were prepared by gritblasting using a water/amine fire suppressant and corrosion inhibitor (approved for use). The supports were bonded to the tank sides.

Testing of similar brackets showed that 12 tonnes force was required to remove the brackets. This process avoided the costs associated with draining and storing the oil, as well as cleaning the tank to make it gas free for hotwork. After 5 years brackets were replaced and welded when tanks were emptied for a full inspection.
